**Flood Control Project Maintenance
Levee Inspections**
LMA District Cover Sheet
Spring 2020 Levee Inspection Results

Madera County FCWCA

Spring 2020 Levee Inspection Results

Waterway			Bank	Unit Miles
Unit No. 01 Ash Slough			Right	2.37
	Spring (March - May)	Summer (June - August)	(September - November) Fall	Winter (December - February)
Unit Maintenance Rating (Fall Only)				
Date of Inspection	4/14/2020 - 4/14/2020			
DWR Inspector	Corey Fujitani			
Accompanied By

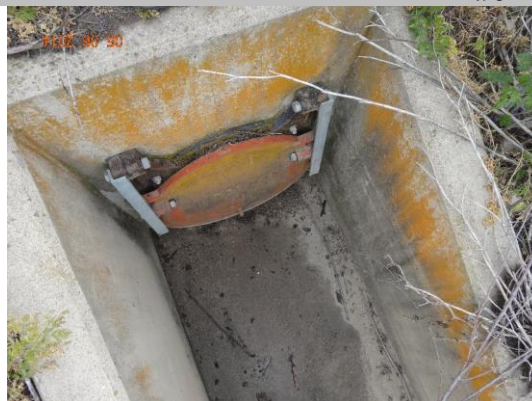
Photo 2 of 3 : UCIP_SP_2020_53156_64604.jpg

Flap gate visible on WS.

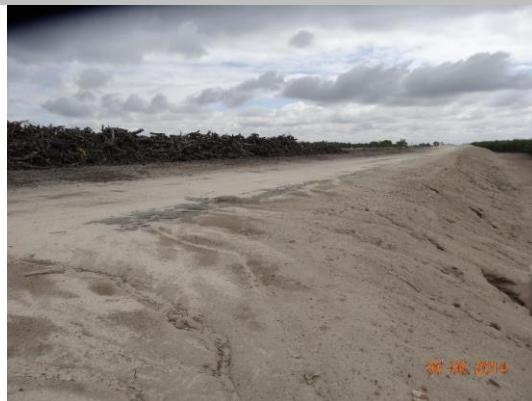
Photo 3 of 3 : UCIP_SP_2020_53156_64603.jpg

View of LS.
